Manhole Inspection Summary

Manhole # S17QQ1049MH

Insp Date: **9/10/07 10:21 AM**

Location Address: **STRAWFLOWER LN**

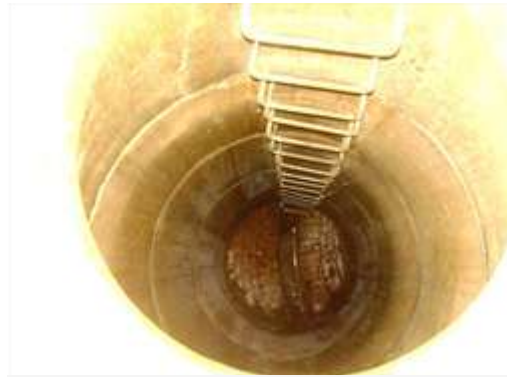
Top View

Bench debris.

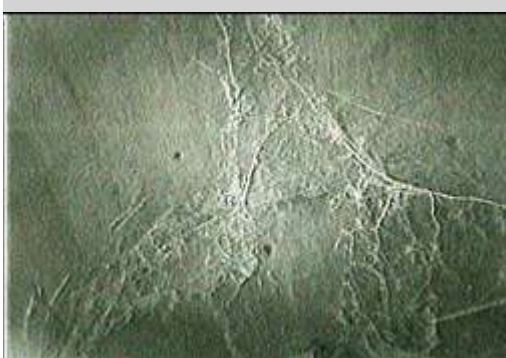
Defect

Condition: ☐ Sound ☐ Cracked ☒ **Root Intrusion** ☐ Loose Brick ☐ Deteriorated

Infiltration: ☐ None ☐ Joint ☐ Cracks ☐ Mortar ☒ **Roots** ☒ **Wall**

Barrel root intrusion and infiltration.

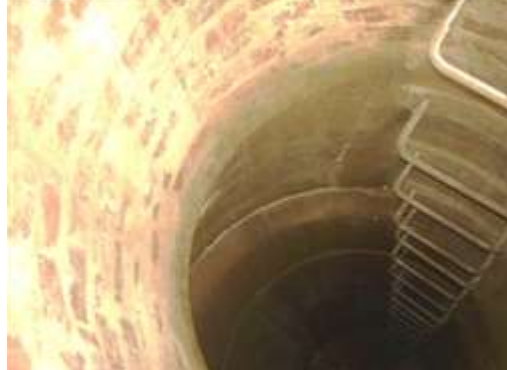
Defect

Infiltration: ☐ None ☒ **Joint** ☐ Cracks ☐ Mortar ☐ Roots ☒ **Wall**

Infiltration: ☐ None ☐ Joint ☐ Cracks ☐ Mortar ☐ Roots ☒ **Wall**

Adjustment, Corbel and Barrel infiltration.
